PRETTY LAKE LEVEL CONTROL STRUCTURE PART 307 INSPECTION

Dam Identification No.: 961
Hazard Potential: Low
Section 11, T. 15 N. – R.08 W.
Martiny Townships, Mecosta County, Michigan

Date of Inspection: April 4, 2017
Date of Report: April 2017

Project I.D. Number 124563SG2017

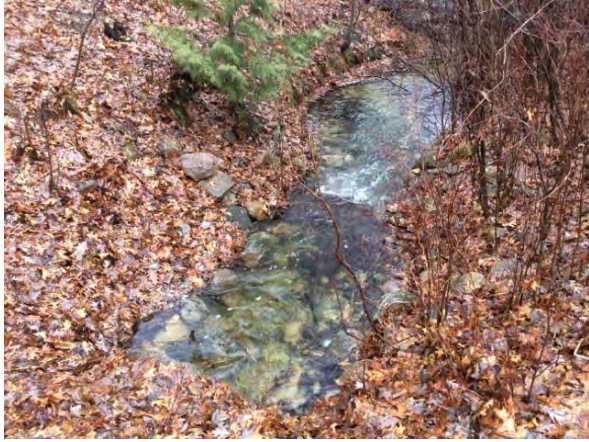
Downstream channel

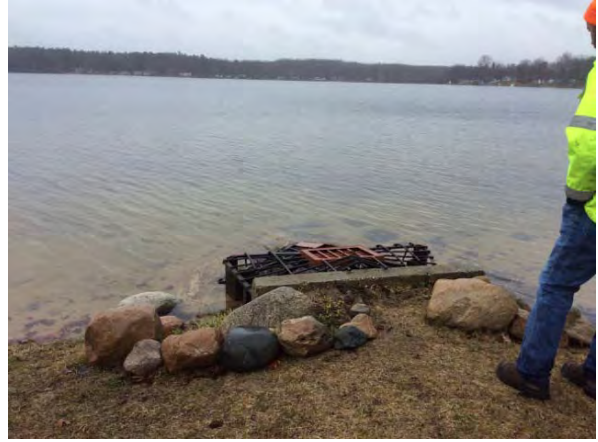
Lake level inlet structure

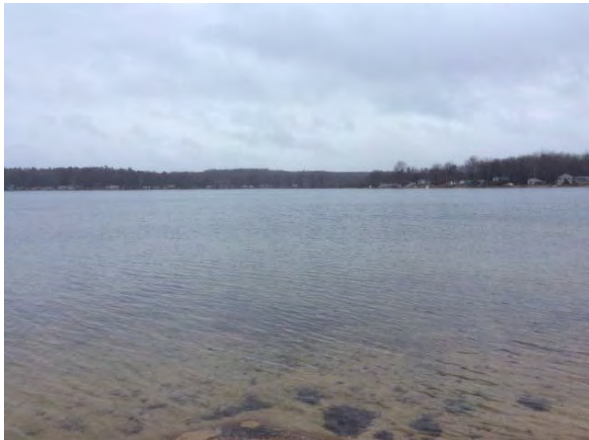
Impoundment

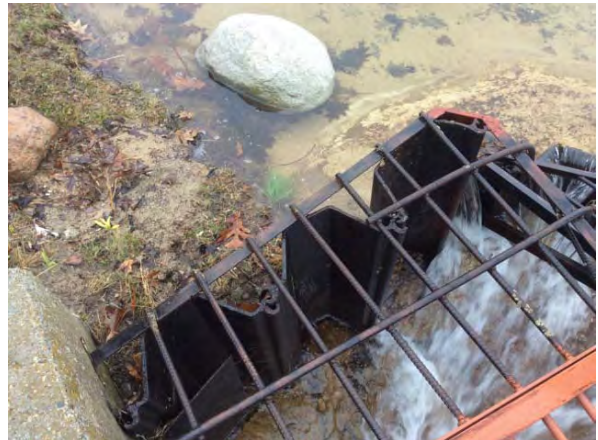
Right side of sheetpile and concrete structure

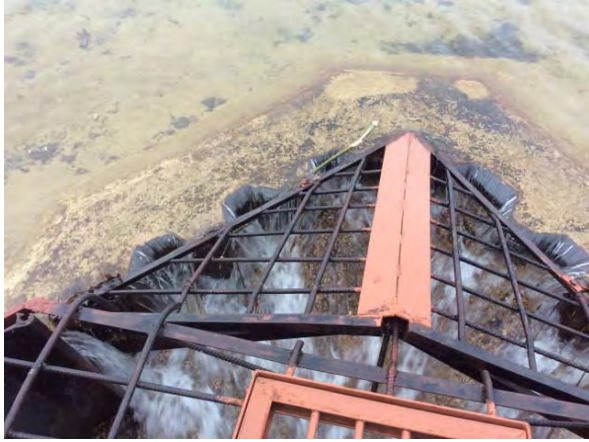
Front of sheetpile and concrete structure

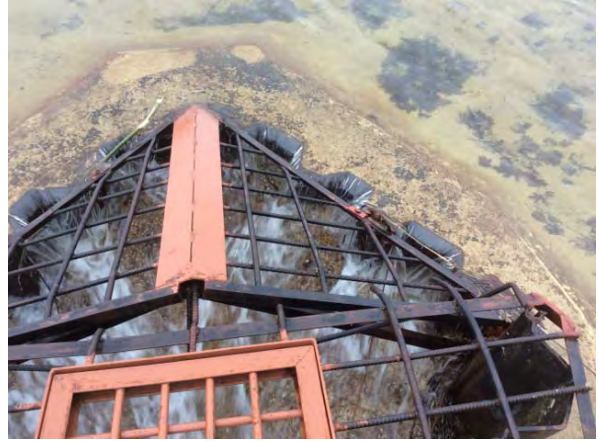
Left front of sheetpile and concrete structure

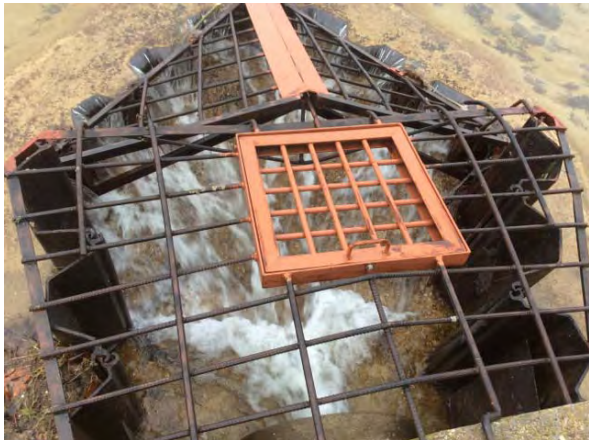
Access hatch on control structure grate

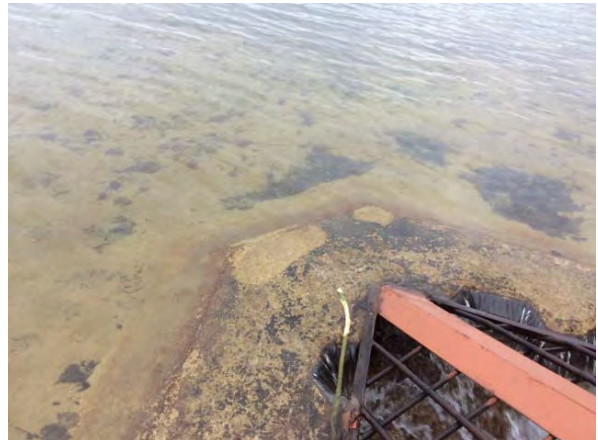
CONCRETE STRUCTURE: Check for erosion; location of cracking or spalling. If old or new; settlement; need for crack repairs. SHEET PILING AND CONCRETE STRUCTURE IS IN GOOD CONDITION. NO CRACKING OBSERVED.	
WALKWAY & RAILING: Check if in place or removed, condition, and if adequate protection provided. N/A	TRASHRACK OR LOG BOOM: Check if operable. NO OBSTRUCTIONS OBSERVED.
EMERGENCY SPILLWAY: Size, type, and condition. N/A

Concrete wall around sheetpile. No cracks observed.

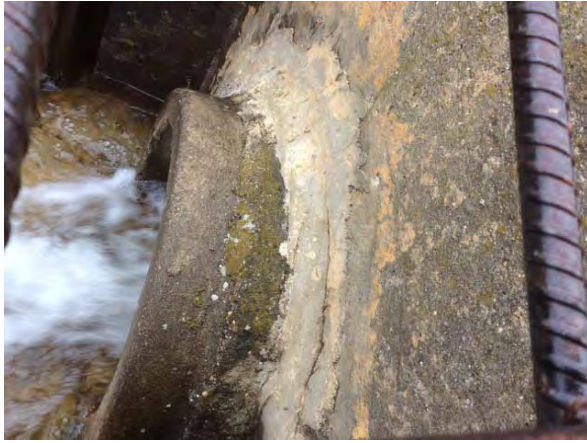
STOPLOG VALVES AND GATES (open and close to check condition): Check location of top stoplog in relation to top of riser pipe intake box or fixed crest, for leakage, and condition of stoplogs, valves and gates. N/A
OUTLET PIPE: Check for damage from ice, logs, vandalism; inside discharge pipe for settlement and/or joint separation; condition of pipe coating. CONCRETE HEADWALL IN GOOD CONDITION. SOME MINOR CRACKING IN MORTAR AROUND 24" RCP PIPE. PIPE APPEARS TO BE IN GOOD CONDITION.

Mortar around outlet culvert. Minor cracking observed.

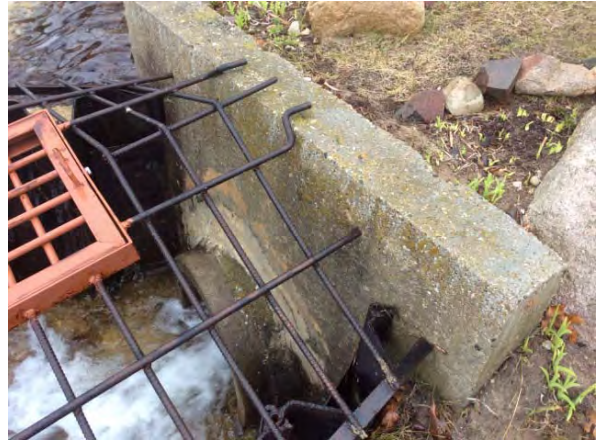
Concrete headwall of structure

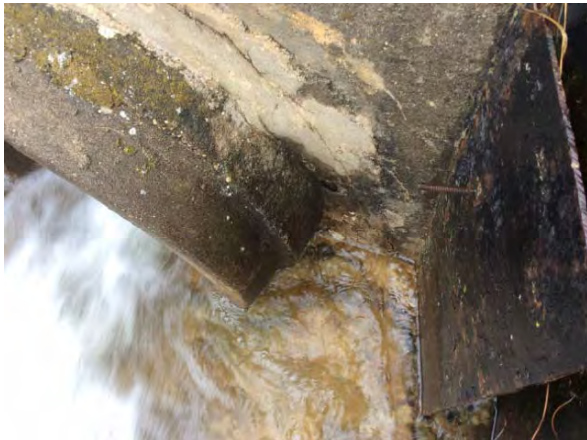
Minor cracking in mortar around culvert

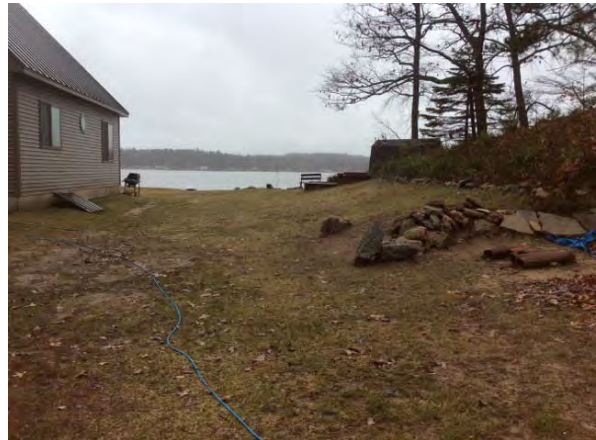
Existing ground above outlet pipe

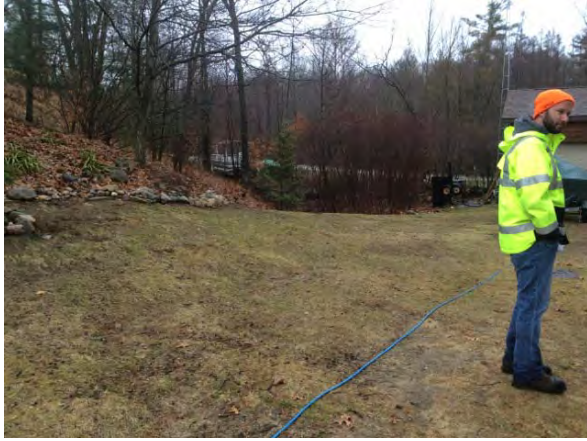
Existing ground above outlet pipe, looking downstream

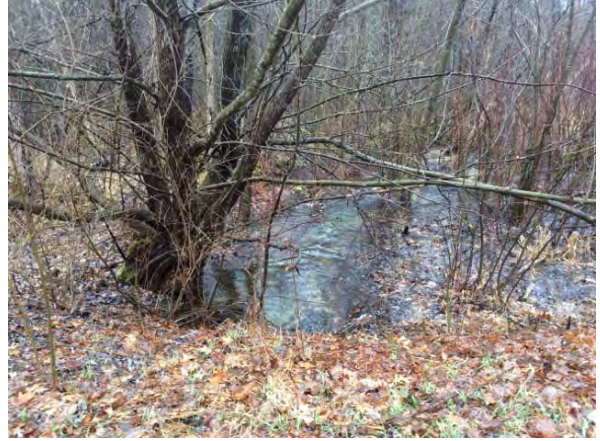
Downstream channel, east of road

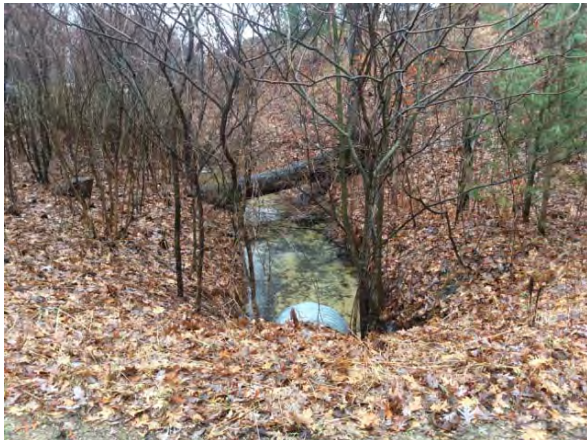
Downstream channel, west of road
